UNION CSD COMMUNITY SCHOOL DISTRICT

FACILITY ASSESSMENT REPORT

MAY 7TH, 2024

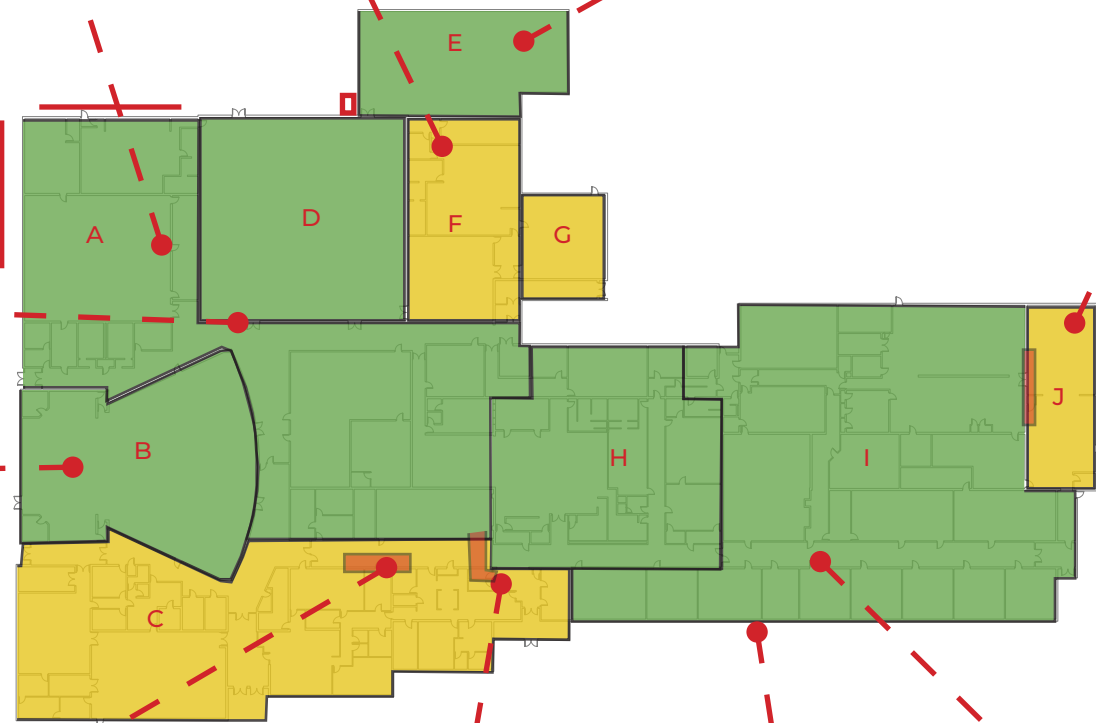
2) WALLS		
a). Brick masonry cavity wall		Appear to be performing well. No major water or structural concerns identified.
b). Portland Cement Plaster		Located on 1974 additions. Spalling. Plan to repair/replace
c). EIFS		Located on 2000 addition. Good condition

3) WINDOWS		
a). Aluminum		Various vintages. No visible issues
4) ROOF		
a). Section A,B,I		Standing seam metal roof by Armco. Date of installation unknown. Signs of leak repair.
b). Section C		Adhered EPDM. Assumed install date 2000. Approximately 24 years old.
c). Section D,E,H		Adhered EPDM. E installed in 2011. D and H are more recent. Good condition
d). Section F,G,J		Adhered EPDM. Date of installation unknown. Plan to repair or replace J

5) SITE		
a). South Parking Lot		Considerable cracking/deterioration. Plan to replace in 1-3 years
b). Exterior Stair/Stoop		Some stoops/sidewalks need addressed
c). Sidewalks	X	Not reviewed
d). Fencing/Gates		Visible fences/gates appear to be performing well
e). East Parking Lot		New asphalt in good condition. Other concrete performing well at this time.
f). General Appearance		Overall good

1. Re-caulk at termination bar where failing
2. Address noted roof repairs
3. Repair Portland Cement plaster on 1974 wing
4. Repair/clean EIFS located on 2000 addition to prevent premature deterioration
5. Clean brick masonry on north elevation
6. Repair/replace south concrete parking lot
7. Perform concrete repairs noted
